Manhole Inspection Summary

Manhole # S31S__016MH

Insp Date: **7/29/09 8:04 AM**

Location Address: **W. Ostend St**

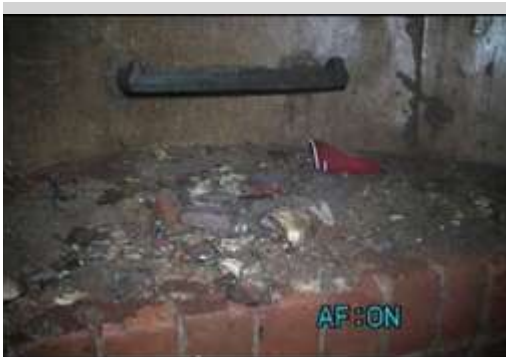
Miscellaneous

debris on bench

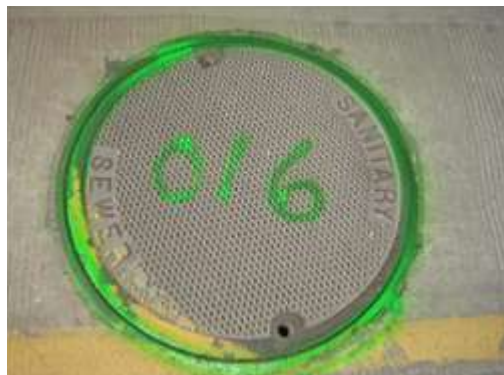
Miscellaneous

mh cover

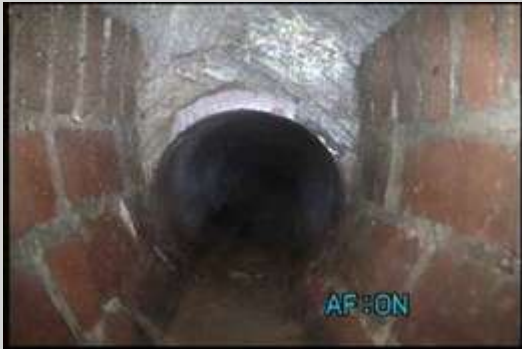
12 O'Clock Outflow

8 in. Circular Gravity Sewer
Pipe Out @ 12 O'Clock

Pipe Height: **8.4** (in.) Rod and Bar (Angled)
Pipe Material: **Clay** ☐ Pipe Lined
Invert Depth: **10.86** (ft.) Flow Characteristics: **Fast**
Deposits: ☒ None ☐ Mud ☐ Sludge ☐ **Debris** ☐ Grease
Silt Depth: **0** (in.) Deposits Extent:
Infiltration: **None** Pipe Seal Cond: **Sound**

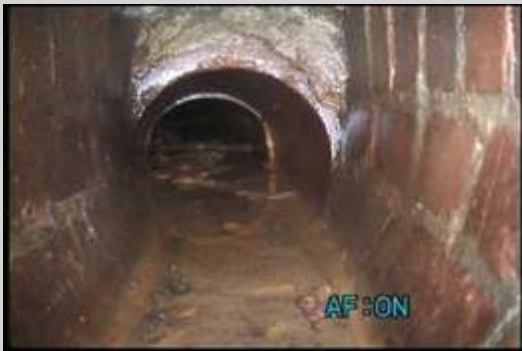
5 O'Clock Inflow

8 in. Circular Gravity Sewer
Pipe In @ 5 O'Clock

Pipe Height: **8.4** (in.) Rod and Bar (Angled)
Pipe Material: **Clay** ☐ Pipe Lined
Invert Depth: **10.80** (ft.) Flow Characteristics: **Fast**
Deposits: ☐ None ☐ Mud ☐ Sludge ☒ **Debris** ☐ Grease
Silt Depth: **0** (in.) Deposits Extent: **Light**
Infiltration: **None** Pipe Seal Cond: **Sound**
